A Guide to the Blocking of Canals and Ditches

in Conjunction with the
Community

Bogor, December 2005

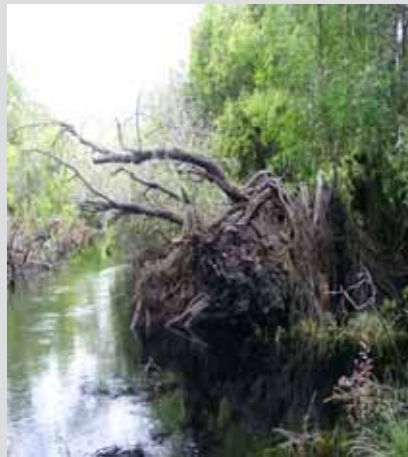
There are many small canals or ditches (with a width of between 60 – 300 cm, a depth of 70 – 200 cm and a length of 3 – 9 km) in the peat swamp forests of Kalimantan and Sumatra. These ditches are dug by loggers to facilitate transport of logs out of the forest. A side effect of the ditches is drainage of the peat, leaving it prone to burning in the dry season. The photographs below show the size of a ditch in South Barito, Central Kalimantan. (Photograph: Alue Dohong).

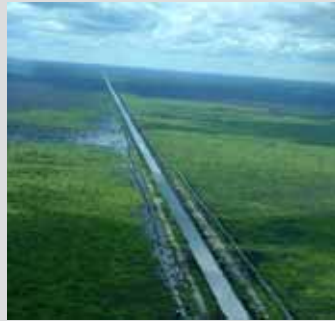
(a) Photograph: Yus Rusila Noor

Photograph a) shows the main primary canal in the ex-mega rice project. The canal is tens of kilometres long with a width of ± 30 metres. In the ex-mega rice project area there are thousands of canals ranging from large (primary) to small (tertiary), with a total length of 4,470 km. The canals, which have been neglected, have led to uncontrolled drainage of the peat, leaving it prone to fire in the dry season. If these canals are blocked, and can be used as ponds which resemble beje/fish ponds, many tons of fish could be caught, and the risk of fire would be reduced.

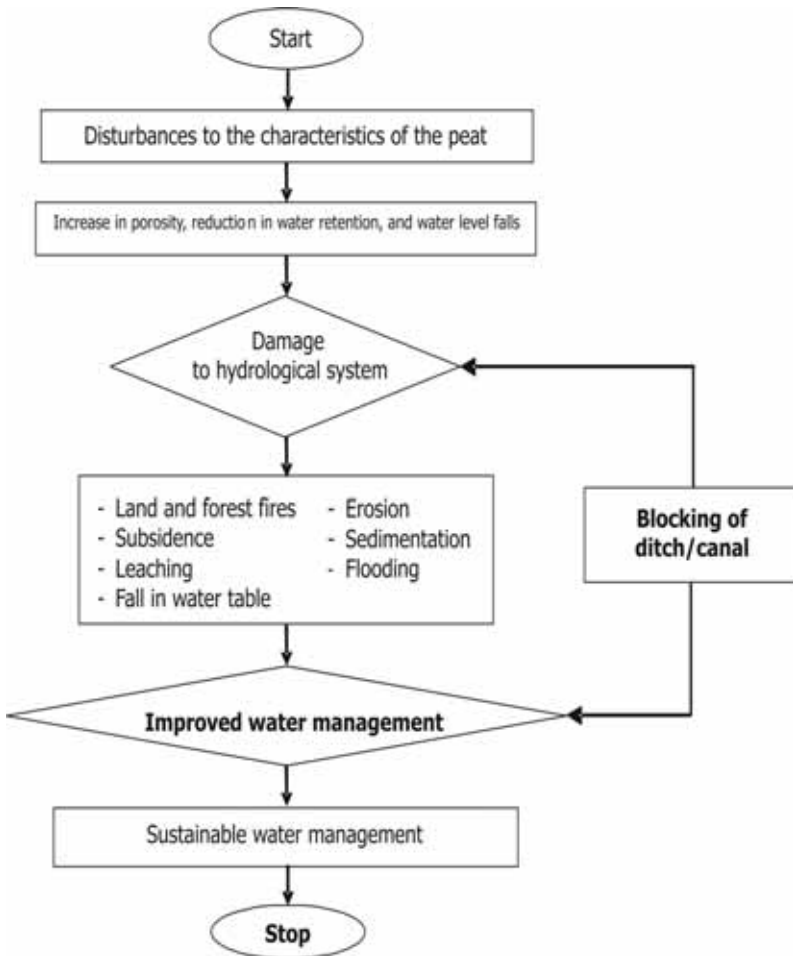
Illustration 3. System to restore hydrology in forest and peatlands (modification from Grigg, 1996)

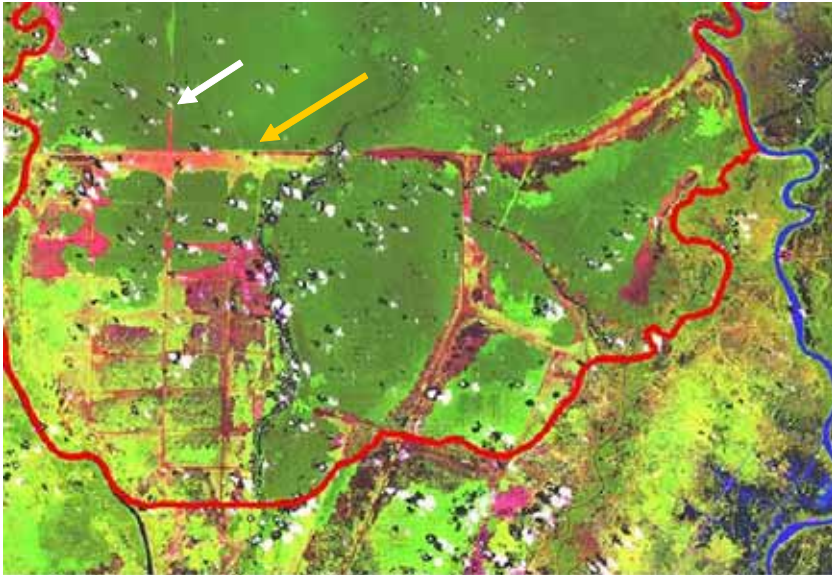
Illustration 4. Satellite image showing the location of a primary canal (white arrow) and the main primary canal (yellow arrow) in Central Kalimantan

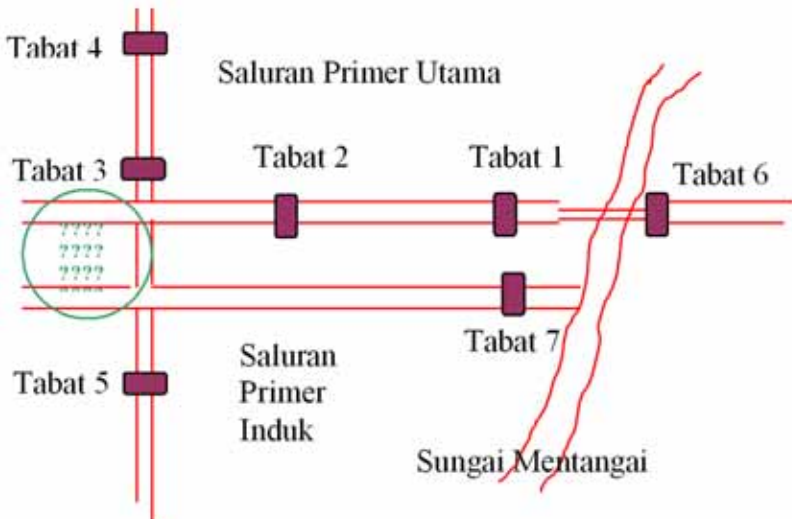
Note: dark colours indicate deeper peat (>12m)

Illustration 6. The location of the canals in relation to peat depth can be seen from the satellite image (top) and the schematic diagram for the location of the blocks (bottom)

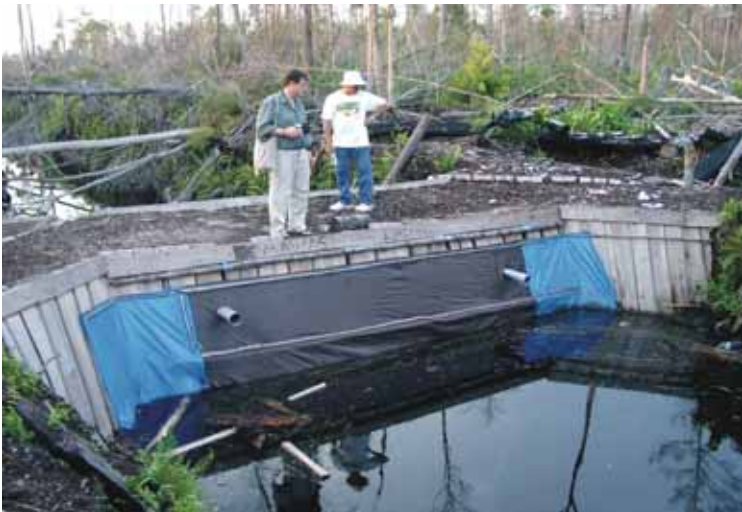
Illustration 11. Composite dam built by Yayasan MAWAS - BOS in one of eks-Mega Rice Project's canal, Kalimantan Tengah

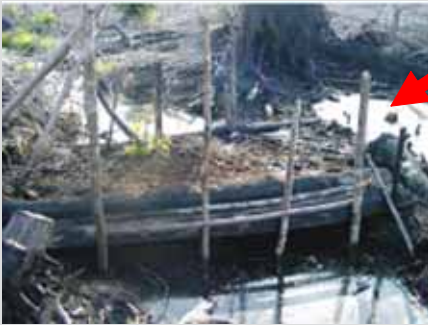
Peat to fill a block should not be taken from the area directly adjacent to the block (see photo a) as the resulting hole can easily fill with surface water during the rainy season, and can damage the block.

WRONG !

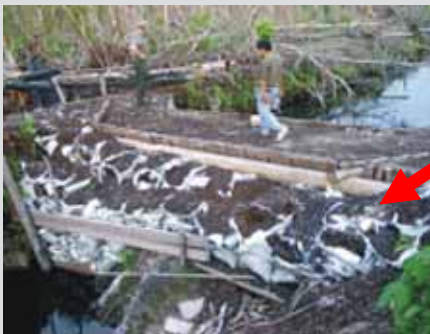
The peat or mineral soil filled sacks are easily damaged as a result of rain and intense heat. The sacks will eventually break open (see photograph b) and the material inside will be carried away by the water. For this reason, using sacks from geotextile is highly recommended.

Photo (b): Peat filled in sacks are damaged

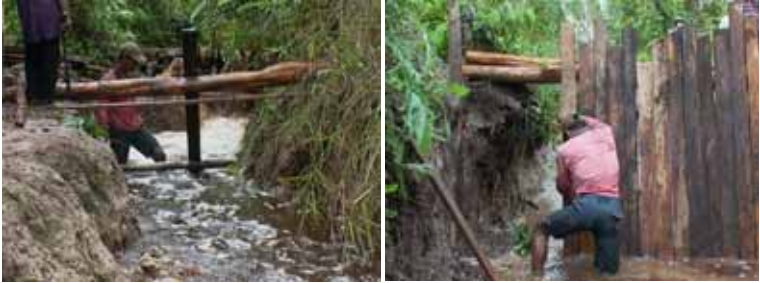
- The horizontal poles be pushed deeply into the peat soil on the left and right banks of the canal (approximately two metres on either side). The vertical poles need to be embedded into the bottom of the canal until they reach the mineral soil layer. This is to avoid damage to the block as a result of water pressure on the sides and the bottom of the block.

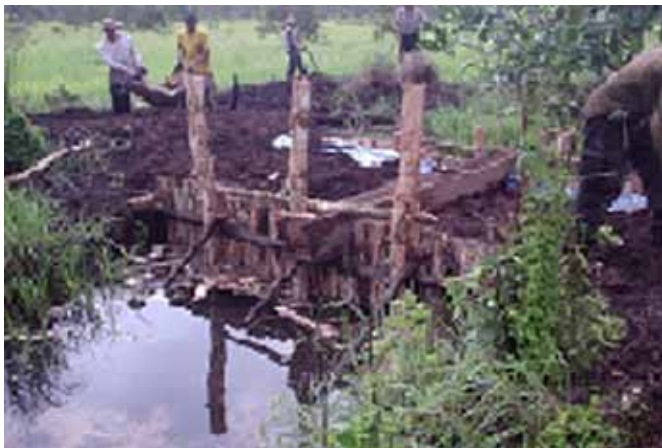
- In the centre of the block it is necessary to build a spillway. It must be capable of releasing excess water during the rainy season, but still able to retain water upstream during the dry season. Therefore, the spillway should not be too deep (a depth of 30cm from the top of the block is sufficient).

- On the outside of the downstream wall, it is necessary to attach supporting poles to strengthen the structure. The supports should be built in stages, and the total should be appropriate for the width of the block and canal (see Illustration).

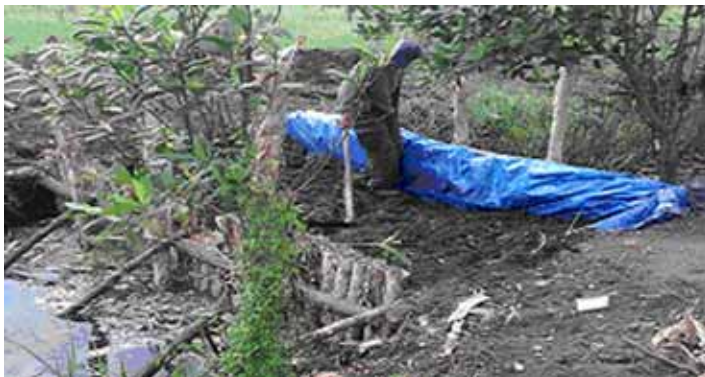
- The inside wall of the block should be lined with a sheet of plastic/geotextile in order to reduce the likelihood of leakage. The plastic must be well attached to the wall of the block so that it does not drift to the surface. The plastic must be immediately dug into the two sides of the canal.

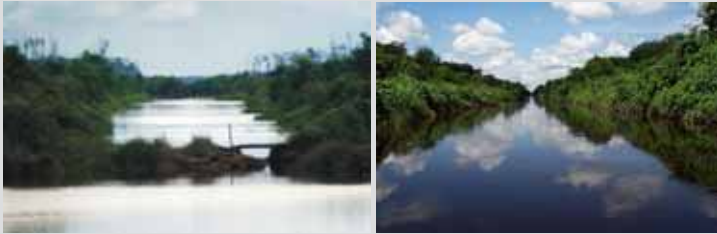
The photograph below on the left shows the condition of the main primary canal in Kalampangan, Central Kalimantan (ex-mega rice project Block C) which was previously blocked by the government. Unfortunately, the nearby community was not made aware of the need for the block, even though they used this canal for transportation purposes. The block has therefore been breached and the canal is once again being used for water transportation. As a result of the damage to the dam, the surrounding peatland has become dry, and burns during the dry season.

The photograph on the right shows the impact of blocking the main primary canal in Kalampangan Village, Central Kalimantan, which has resulted in accelerated re-greening of the area.

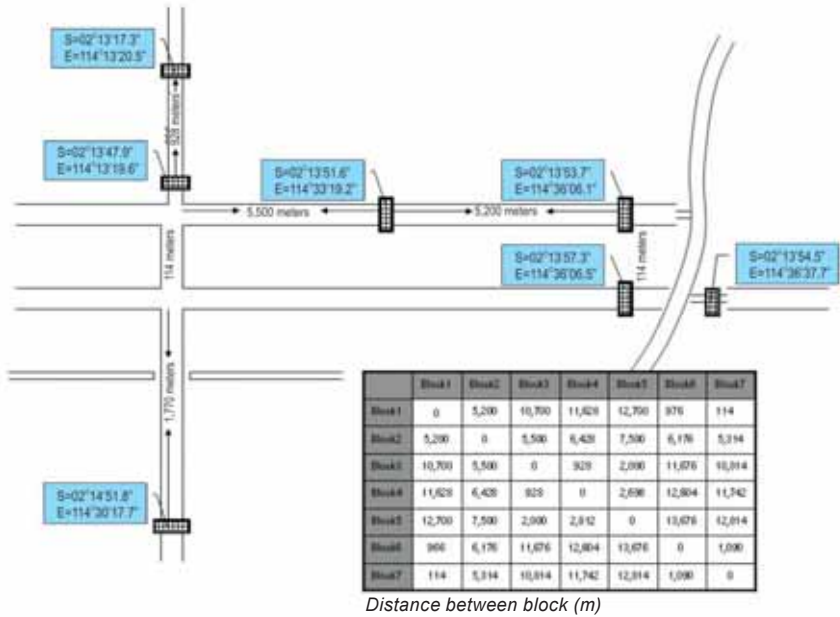
Illustration 22. Sketch of Location of Blocks Built in Block A of the ex-MRP

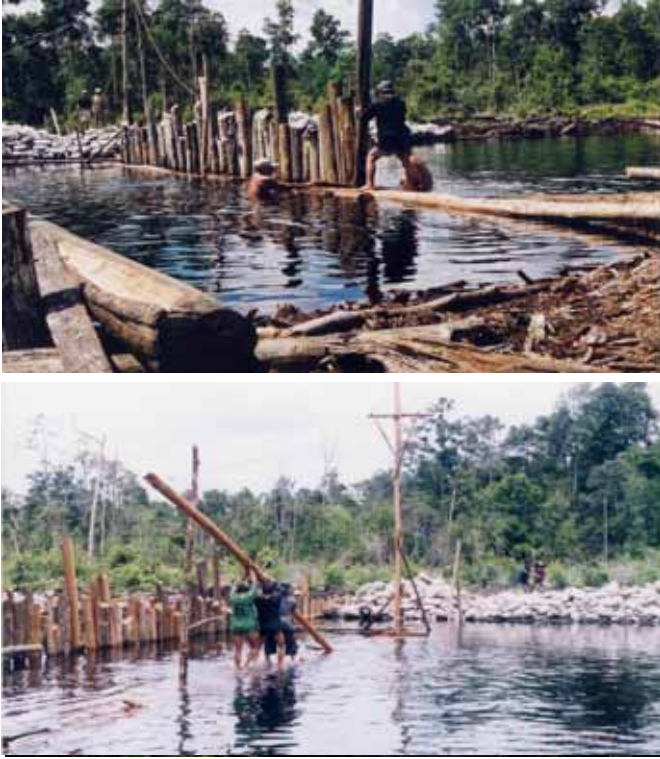
Illustration 30. Workers inserting the wood poles (top) and lifting the joining belangiran pole (Photograph: Suryadiputra 2004).

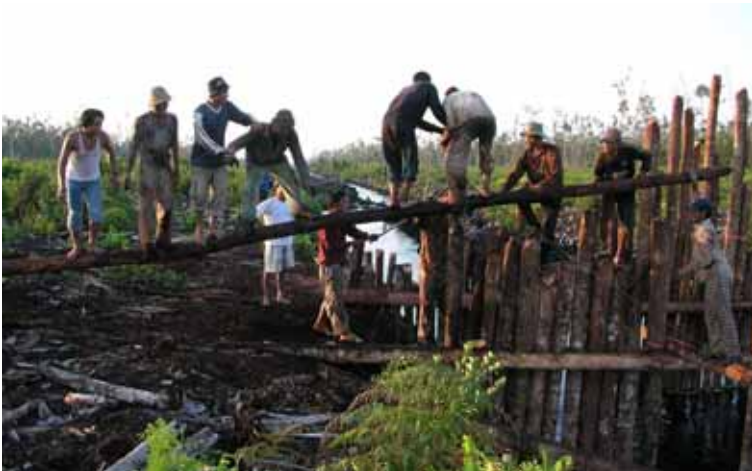
- (4) The poles were inserted, starting from one shore of the canal moving towards the centre until reaching the other side. The steps in inserting the poles were as follows: i) a rope that was already tied to the tower was tied to the unsharpened end of the *belangiran* pole; ii) the pole was raised by one or two people pulling the rope while someone else held on to the sharpened end of the pole and directed and inserted it into the peat at the bottom of the canal; iii) once the position and direction of the pole were finalized, it was inserted into the peat by weighing down the top of the pole with the body weight of the workers, while at the same time moving the pole back and forth so that the pole would enter into the peat more easily. The process continued until the pole reached the mineral soil layer or the pole had gone as far as possible, and could not be moved any more. In order to speed up the process of inserting the poles, a horizontal log was used that the workers jumped up and down on to force the pole in (Illustration 31).

Illustration 31. *Workers jump up and down on horizontal log
(Photograph: Suryadiputra 2004).*

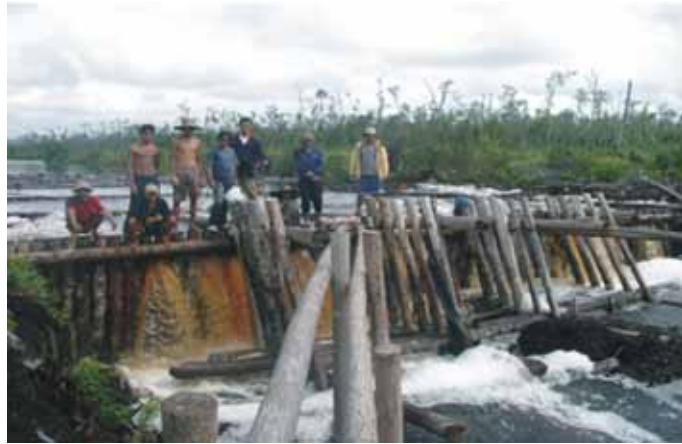
- (5) Fastening the bracing poles to the back of the block. For TDM-1, between six and nine bracing *belangiran* poles were used, depending on the dimensions of the canal. They were placed at the back of the block and inserted into the soil in a parallel fashion with an average slope of 45°. The bracing system for TDM-2 used five to six parallel rows of poles also with a slope of 45° (Illustration 32) Each row had four to five bracing poles that were tied and bolted together.

Illustration 32. *Belangiran bracing poles at the back of a block (Photograph: Suryadiputra 2004).*

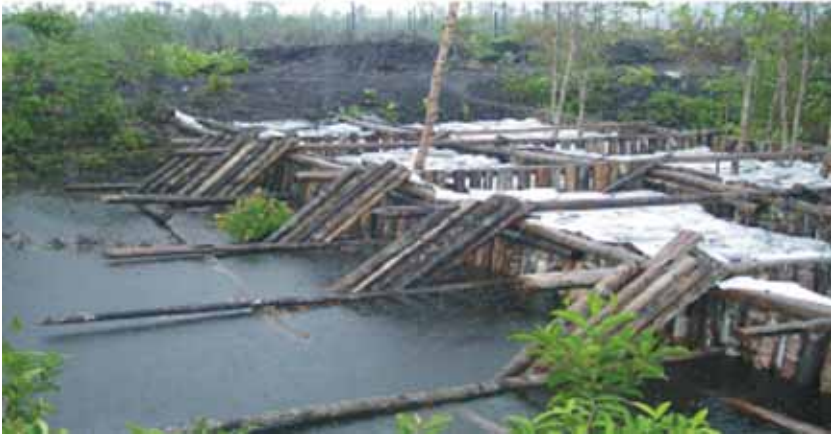
- (6) The next step was to drill the vertical and horizontal poles, and to join the two using nuts, bolts and washers (size 0.25" x 35-45cm).
- (7) Once the vertical and horizontal poles were joined, the tops of the vertical poles were cut with a chain saw so they were straight and neat.
- (8) For TDM-2, the work was increased by the need to make the chambers between the walls of the block. These chambers were made from *belangiran* poles with a diameter of 15cm, and length of 8-10 metres. They were attached to the horizontal poles using nuts and bolts.

Illustration 33. TDM-2 with chambers inside and bracing poles on the down-stream side. This block has already been lined with geotextile, and the chambers filled with mineral soil filled sacks (Photograph: Suryadiputra 2004).

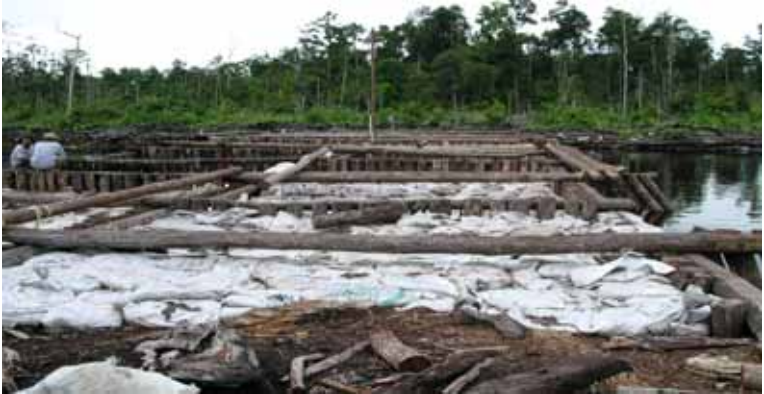
The last stage of construction involved arranging the soil sacks so that they looked orderly.

Illustration 34. Block SPP-SPU7 after being filled with soil sacks (Photograph: Suryadiputra 2004).

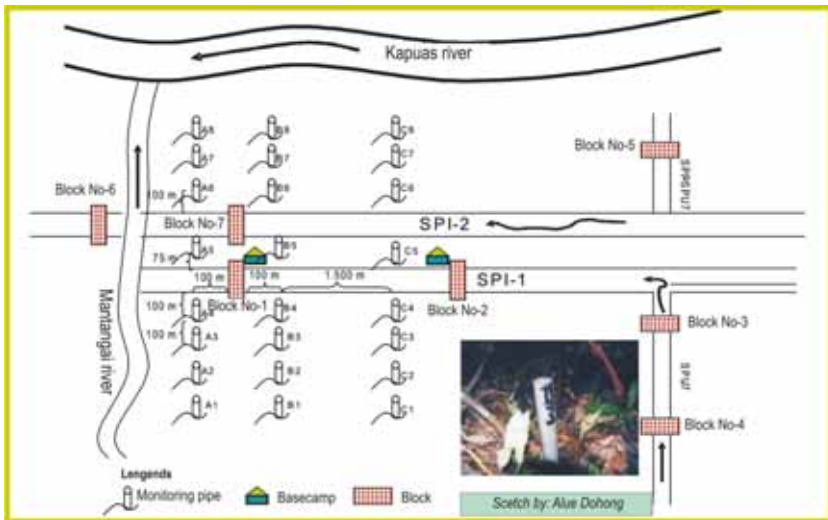
Illustration 36. Location of the bores/pipes to measure ground water change near the blocks on SPI-1 and SPI-2

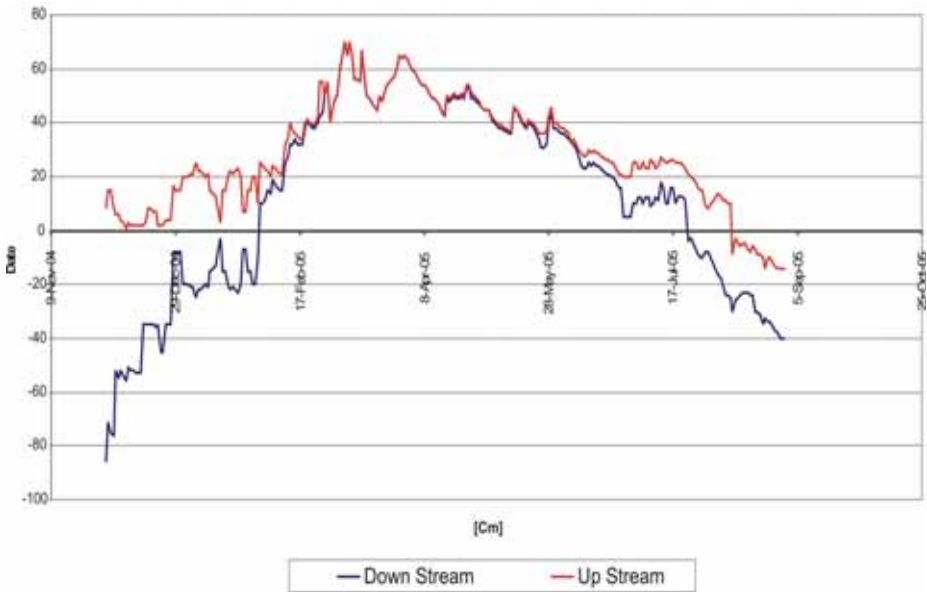
Illustration 38. Graph Showing the Difference Between the Upstream and Downstream Water Levels at Block SPI-1 No1. During December 2004 – Aug 2005.

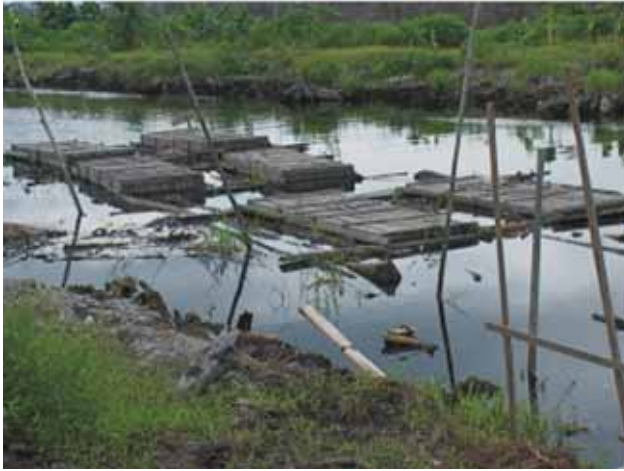
One positive impact of blocking the canal/ditch was that the enclosed area could be used as a fish pond. Physically these ponds resemble the *beje* ponds which are frequently found in peatlands in Central Kalimantan. Like the *beje*, the canal ponds can be used to catch fish. When the nearby river and surrounding areas experience flooding, the fish are carried inland by the flood waters. When the water level falls, fish are trapped in the ponds. These fish can be used as “savings” for the owner of the ponds, meaning that they can be harvested in stages once the dry season arrives. Fish cages where cultivated fish are raised can also be built for use in the blocked canals. This makes harvesting the fish easier. (note: wild fish such as giant snakehead should not be cultivated in the cages by feeding them small fish from the wild, because this will reduce the biodiversity of the fish species in the nearby waters).

Illustration 39. Fish cages in the canal. The total number should be limited in order not to compromise the water quality in the canal (Photograph: Yus Rusina Noor 2004)

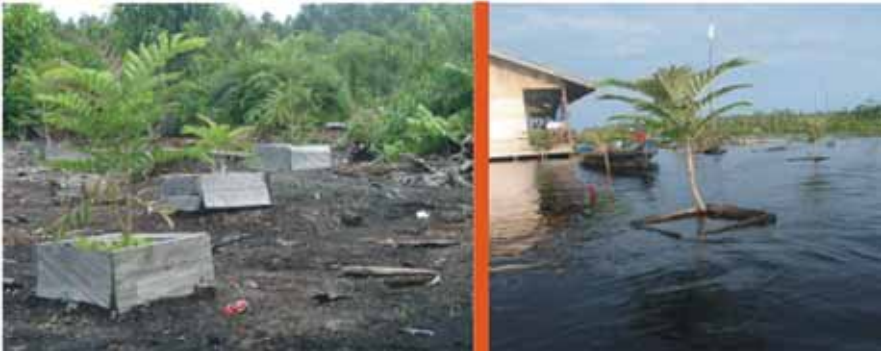
Approximately 200 plants were planted near the camp. These included *Peronema canescens*, *Hibiscus spp.*, wild rambutan *Nephelium mutabili*, jelutung *Dyera lowii*, pulai *Alstonia pneumatophora* and belangiran *Shorea belangeran*. A number of the plants (especially *Peronema canescens*) were planted on mounds that were built for that purpose. The total survival rate of plants near the camp was estimated to be 95%.

Illustration 40. Sungkai plants on mounds near the camp at SPI-1 (left, December 2004; right, March 2005).
(Photograph: Suryadiputra)

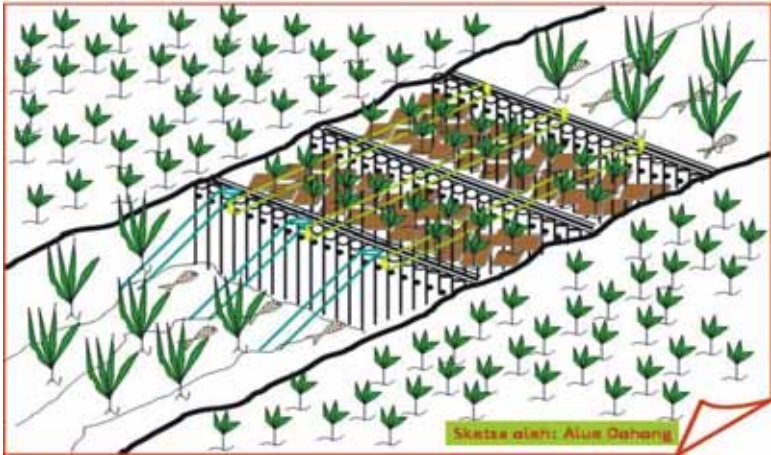
As the block is constructed of wood, and wood weathers, the blocks have a limited lifespan. In order that the blocks will last longer, it is necessary to plant vegetation on top of the block, and in front and behind and on the nearby land, as shown in the sketch below.

Illustration 41. Sketch of Planned Rehabilitation near a Block

The type of vegetation planted above and below the block in the canal included pandanus (*Pandanus atrocarpus*). On the left and right of the block, vegetation planted included belangiran (*Shorea blangiran*), perupuk and tumih (*Combretocarpus retundatus*). Pandanus was chosen because it is good at holding sediment, grows quickly, and is a favoured spawning habitat for fish.

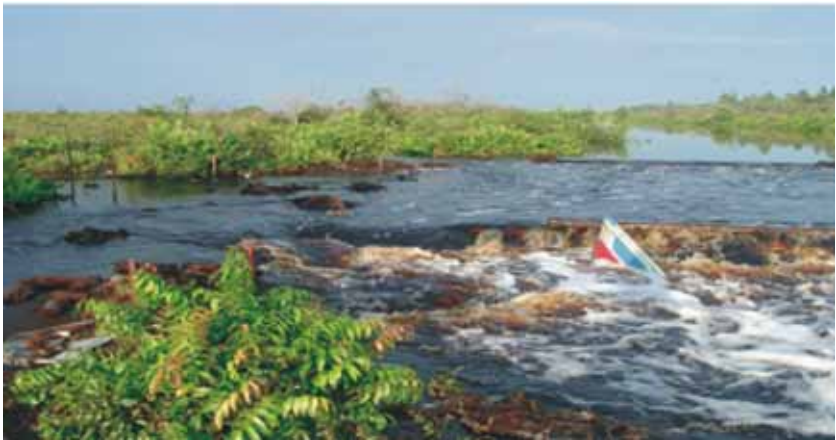
Illustration 46. Strong water flow at block 2, SPI-1 slightly erodes peat on the side (Photograph: Suryadiputra, March 2005)

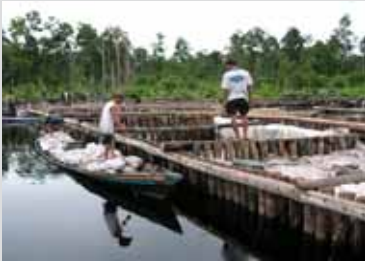
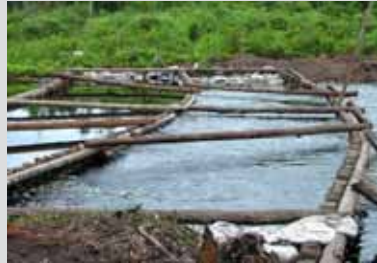
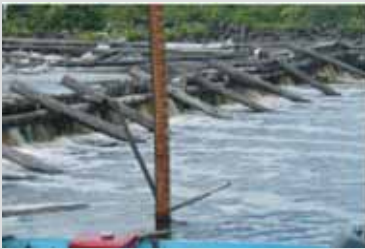
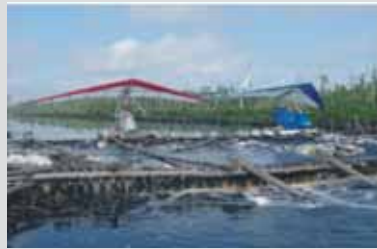
Box 8.

Tabat 1, with a width of 27 metres, used the TDM 1. This was the first block built by the CCFPI project in the SPI-1 and was completed in June 2004 (see picture a). During the rainy season in October 2004, when the discharge rate and current of SPI-1 increased, the block bowed (picture b). However, the current did not break the block. This indicates that the belangeran wood used as the main construction material was strong enough to withstand the pressure of the water. In November 2004, a strengthening cable was attached from either side of the block to stakes in the ground. Several supporting posts were also added to the outside wall of the block, on the downstream side. These actions served to restore the form of the block, so that it was straight and held back water in the canal (picture c). In fact, the blocked section of canal was used for parking the BOSF patrol plane (picture d).

In November 2004 WWF-Indonesia completed two blocks in the ex PT-SSI canal in the Sebangau area. As with the blocks built by WI-IP in the SPI-1 (see box 8), not long after construction the blocks were damaged. The causes of the damage to the Sebangau blocks include:

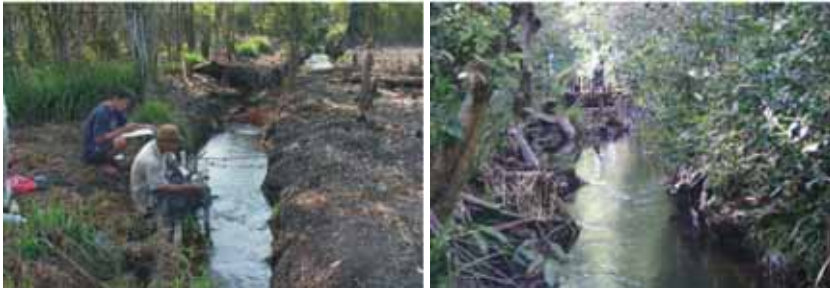
The ditches in the locations identified above were relatively small, with a width of between 1 – 2 metres, a depth of between 0.75-1.5 metres and a length of 3-7 kilometres (see illustration 49).

Illustration 49. Dimensions of the Ditches in the Black Water Ecosystem, Puning River. (Photograph: Suryadiputra 2004)

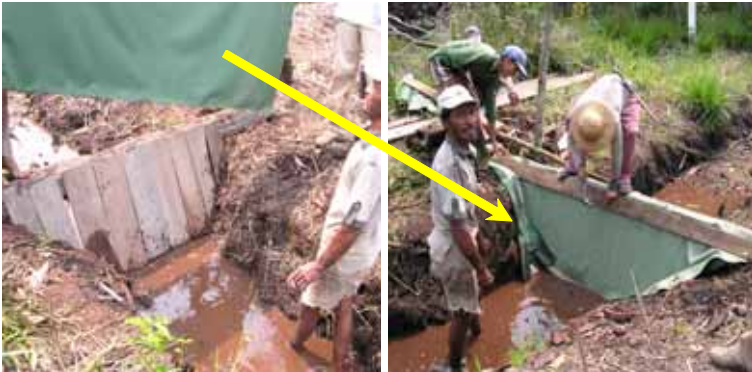
Illustration 50. Attaching the Plastic or Tarpaulin to the Wall of the Block (Photograph: Alue Dohong, 2003)

- i) Clearing the location to be blocked (twigs, branches and wood stumps in the ditch were removed)
- ii) Two wood beams were inserted horizontally in the ditch. One was lowered to the bottom and the other placed across the top of the ditch. These beams were inserted far into the land on both sides of the ditch in order to ensure that they would be strong enough to support the vertical planks that would need to withstand the pressure of the water.
- iii) The planks and beams were fastened vertically (slightly tilted upstream) and evenly and attached with nails to the horizontal beams.
- iv) Activities ii) and iii) were repeated at a distance of approximately two metres downstream, so the block had the form of the letter U or a trapezoid.

- v) The protrusions of wood at the top (see point iii) on both sides of the block were evened up using a saw. After this a plastic sheet was carefully attached, making sure that it did not rip.
- vi) The part of the ditch that was blocked ("U" form) was filled with mineral soil or peat taken from a location some distance from the block.
- vii) The earth in the block was tidied up so that it was even with the top of the block.
- viii) Vegetation or seeds were planted in the soil.

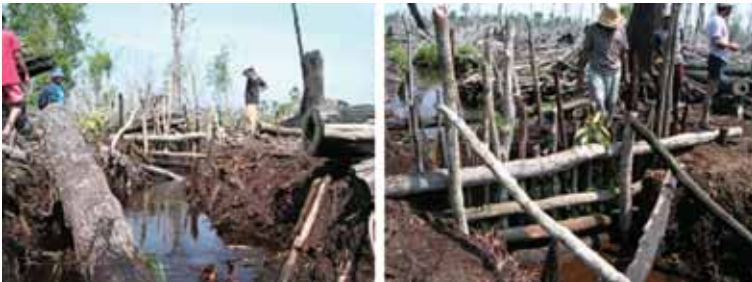
Illustration 51. Constructing the Block (Photograph: Suryadiputra, 2004).

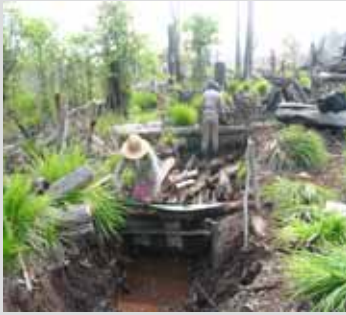
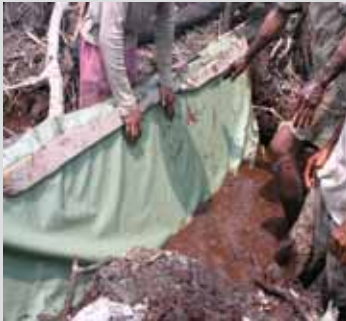
Box 9

The photograph to the side shows ditch blocking activities in the sub-village of Muara Puning, Barito Selatan District, Central Kalimantan. This canal was unused and neglected and caused the surrounding peat to dry out, leaving it prone to fire. The area burned in 1998 and again in 2002. Materials that were easily available nearby were used for the block (wood logs, boards and compressed peat for the filling). Blocks were made at several locations, depending on the topography and slope of the land. The purpose was to raise the ground water level so that the peat would remain wet during the dry season, and therefore be difficult to burn. A rise in the ground water level would also support succession and rehabilitation of vegetation near the ditch. Most of the nearby land has been burnt over.

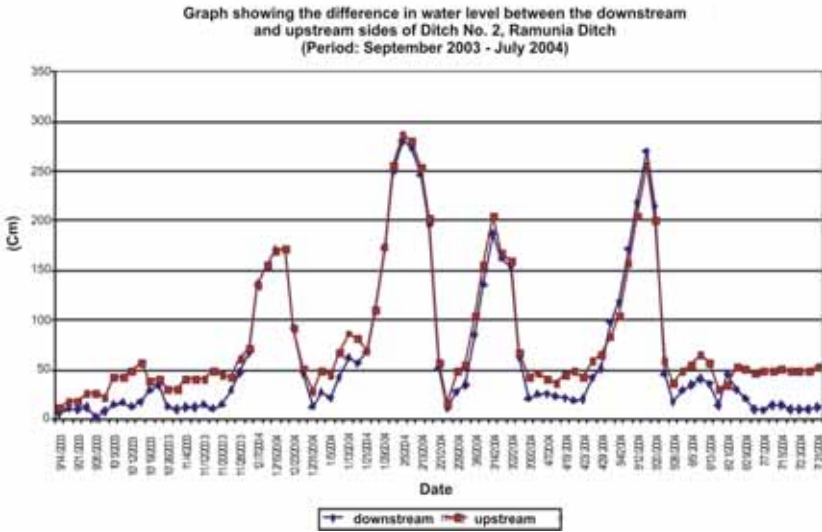
Illustration 55. Graph showing the difference in water level between the downstream and upstream sides of ditch No. 2, Ramunia Ditch

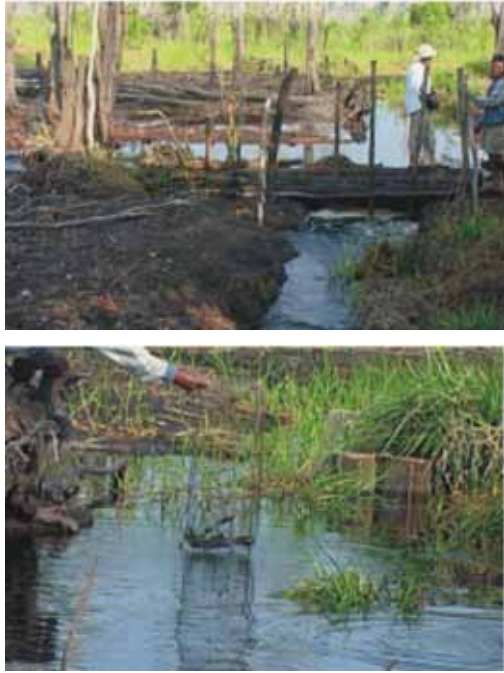
Illustration 56. Difference in water level above and below the block (top) and fishing activity in the blocked section of Ramunia ditch (bottom) (Photograph: Suryadiputra, June 2004).

From the two graphs above it is evident that during the dry season (end of May until November) there is a difference in the water levels above and below the blocks of up to 40cm and the peat near the blocks remained wet (Illustration 56, left). This had the effect of reducing the likelihood of peatland fires during the dry season. In addition, in the two ditches that were blocked, many fish were trapped during the rainy season. The total number of fish trapped during one rainy season was reported as being more than 200kg for one section of a ditch approximately 500 metres long, 1.5 metres wide, and 70cm deep. More than 16 species were found (please refer to Table 9 for scientific names of the fishes), including: *channa striata*, kihung, mehaw, sepat rawa, seluang ekor merah, seluang ekor putih, kakapar, biawan, papuyuh hijau, papuyuh kuning, lele pendek, pentet/lele panjang, julung-julung, lais, kelatau took and tombok bander. (Illustration 56, right).

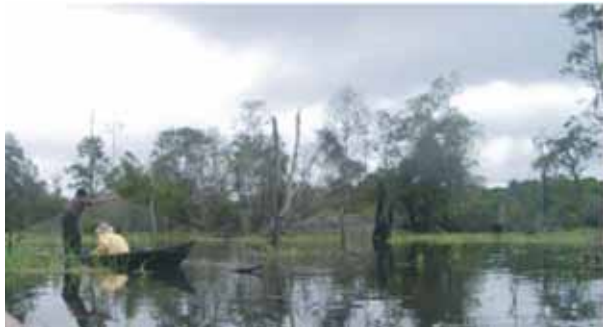
Illustration 57. Ramunia ditch flooded during the rainy season (Photograph: Suryadiputra, December 2004).

During the rainy season (especially from December to February) the ditches overflowed to a depth of three metres (Illustration 57).

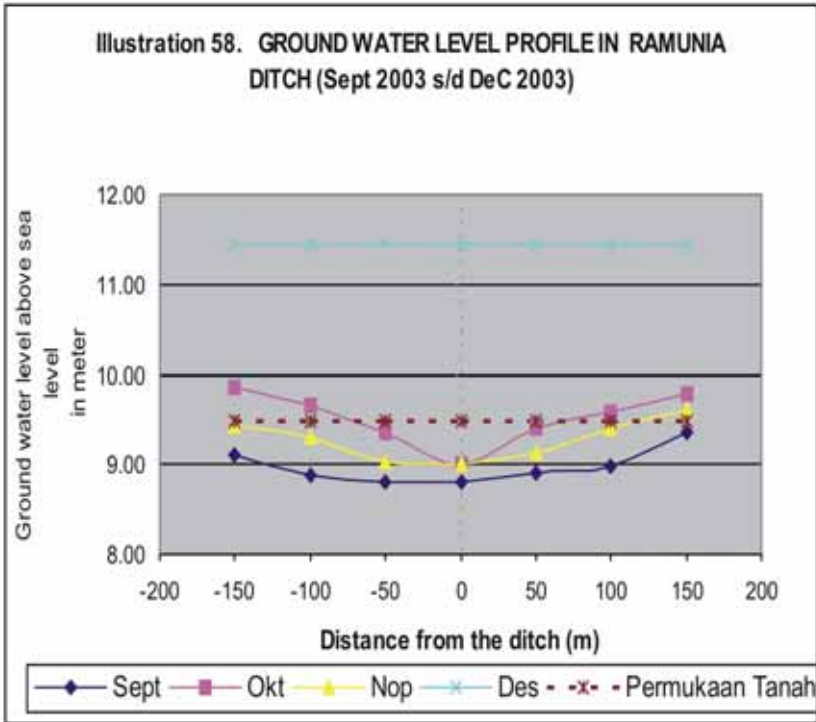
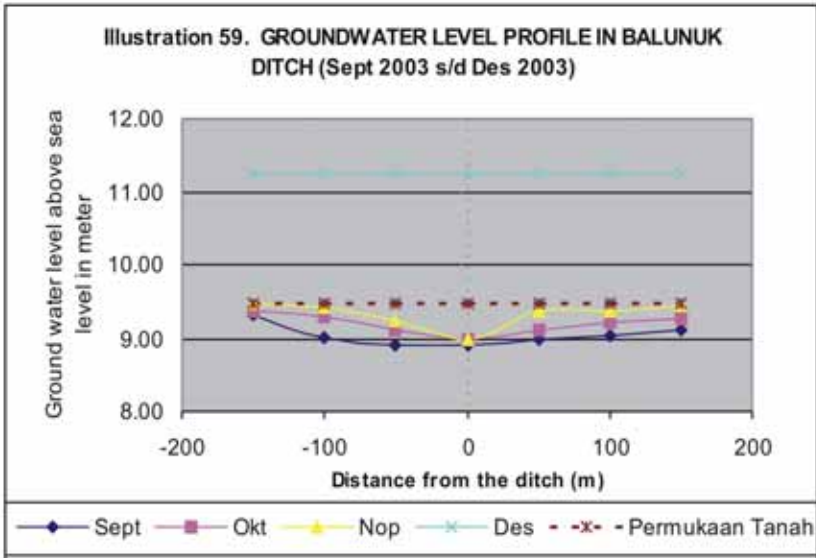
The two graphs above show the change in ground water level in the peat near the blocked ditches of Ramunia and Balunuk (the data was collected from September to December 2003). The two graphs show a similarity in the

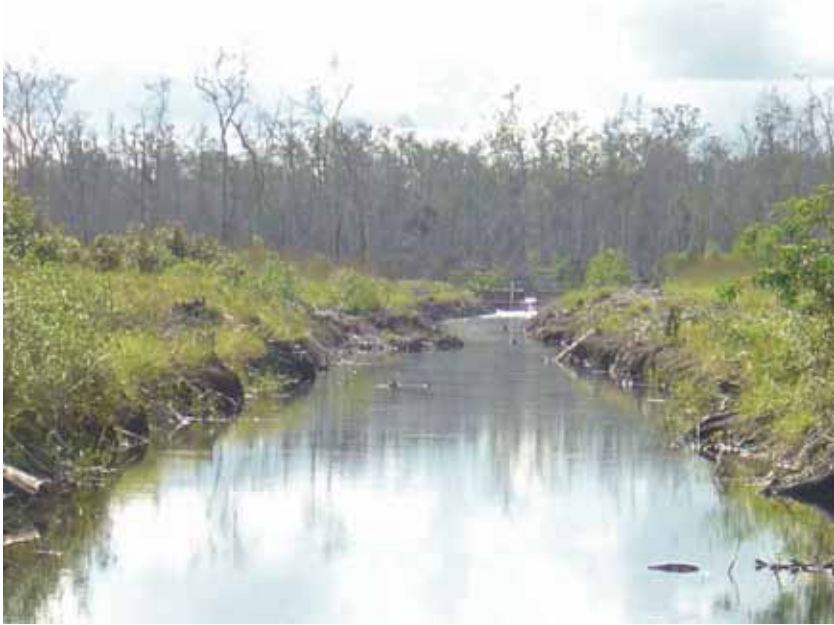
Illustration 69. Location of the canal in the ex PT SSI – Sebangau area (water conditions during the dry season)
(Documentation: WWF- Indonesia/Drasospolino, 2004)

Location	Ex-PT SSI Area	Sami Canal
Position	S 02° 34' 48.9" E 114° 02' 35.3"	S 02° 40' 57.5" E 113° 58' 29.9"
1. Dimensions of the block to be built		
- Length	12 m	2.5 m
- Width (= width of the canal)	9 m	2 m
- Peat depth	1.5 m	0.60 m
2. Water conditions (rainy season)		
- Depth of water in the canal	3.15 m	0.9 m
- Water current speed	0.14 m/sec	0.08 m/sec
- Water discharge rate	3.60 m ³ /sec	0.10 m ³ /sec
3. Water conditions (dry season)		
- Depth of water in the canal	0.72 m	-
- Water current speed	0.19 m/sec	-
- Water discharge rate	0.51 m ³ /sec	-

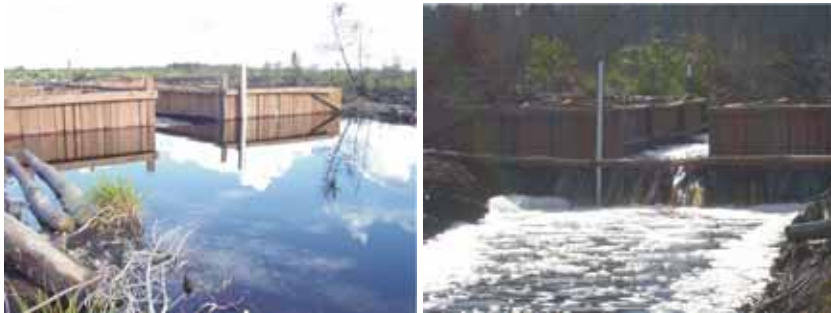
Illustration 72. Construction of Block in ex-PT SSI Canal after Completion (Documentation: WWF-Indonesia/ Drasopolino, 2004)

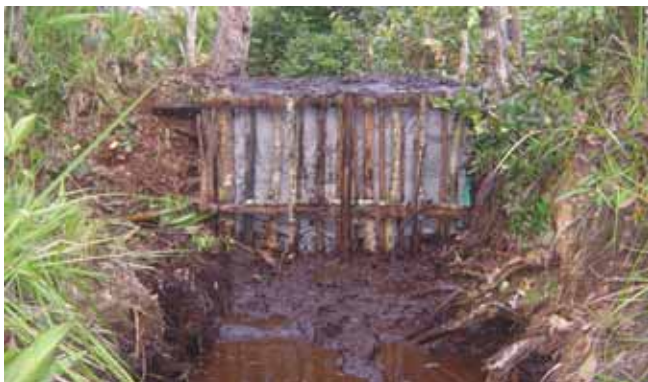
Illustration 73. Construction of Block in Sami Canal after Completion (Documentation: WWF-Indonesia/Eko Manjela, 2004)

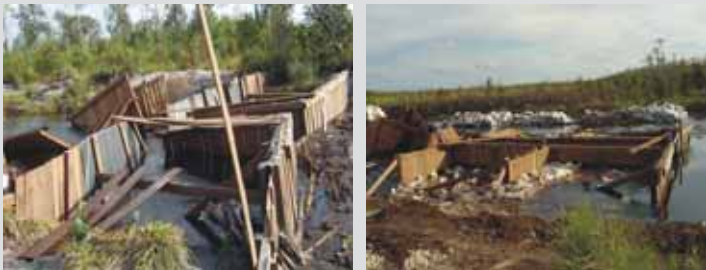
Blocks that were built on the upstream (left) and downstream (right) of the ex-canal of PT SSI were damaged by strong currents in January 2005 (Documentation WWF-I, Sebangau 2005).

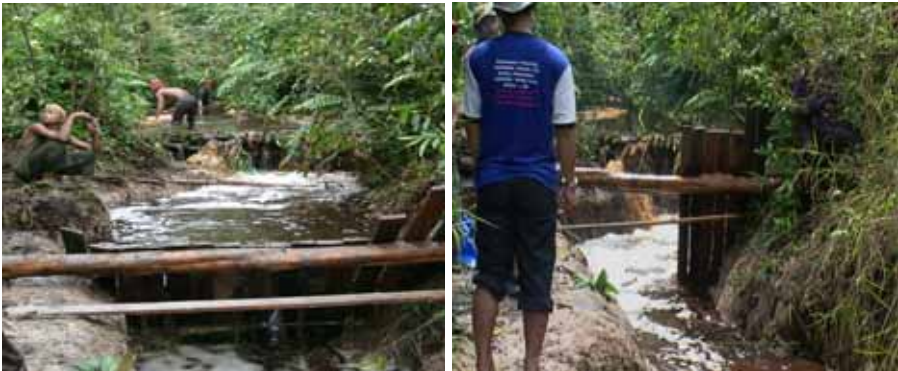
Illustration 75. System of opening and closing temporary blocks in ditches near the Merang River. Left: Closed block with a log being floated down. Right: Open block so the log can float by. (Photograph: Suryadiputra, June 2004)

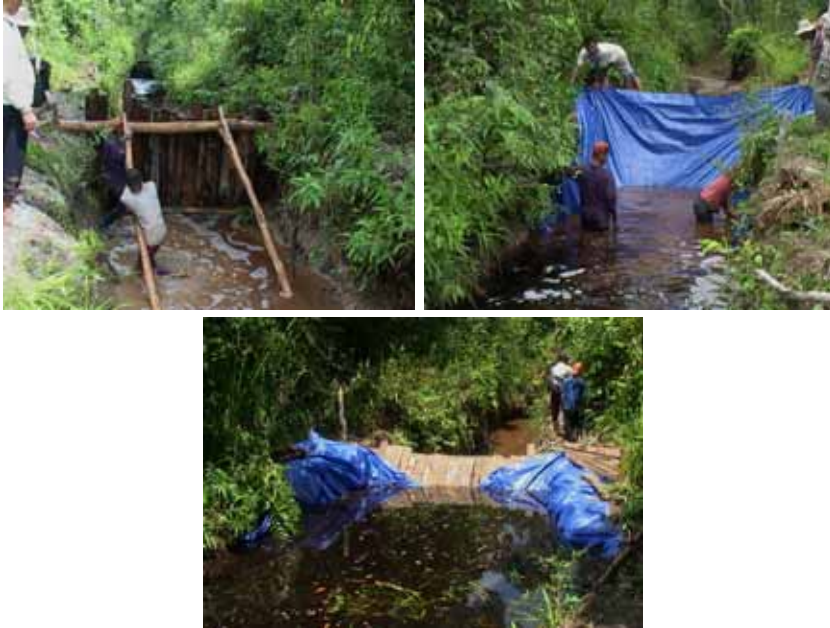
Illustration 76. *Stages of building the temporary blocks by CCFPI in the ditch owned by Nasir (coordinates: S 01°57'34.0", E 103°59'08.7"). This block was later damaged by unknown illegal loggers. (Photograph: Suryadiputra, 2004)*

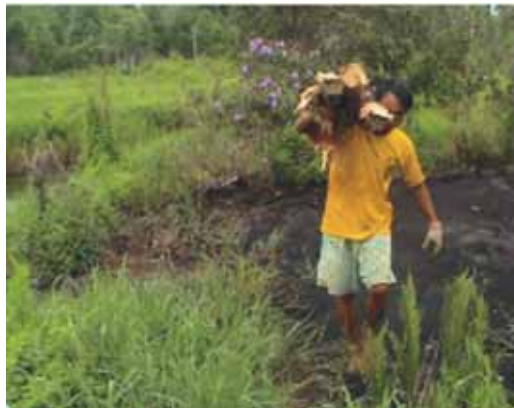
Illustration 78. Collection of materials for constructing the dam.

- *Collection of materials.* The first stage was to gather the main materials for constructing the dam, including: wood cross supports from tembusu wood and stakes from cajuput wood. This wood was gathered from various locations in the forest near the ditches, in order to avoid one area being damaged.

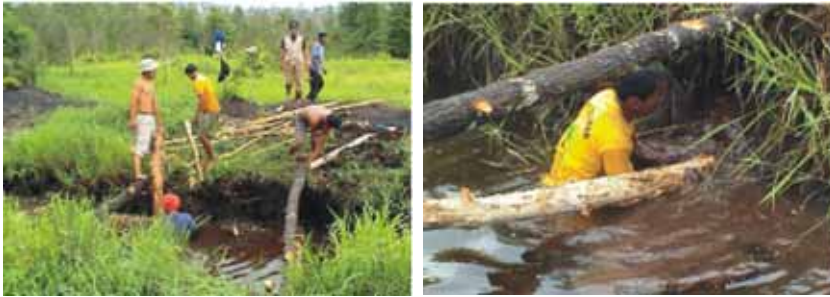
- ❑ *Installing Top and Bottom Cross Supports.* The top and bottom cross supports (from tembusu wood) were installed across the centre of the ditch. Before the two supports were installed, indents were made on the right and left bank of the ditch so the supports could be inserted. The top and bottom cross supports were each six metres long, with a diameter of approximately 15-20 cm.

Illustration 79. *Installing Top and Bottom Cross Supports*

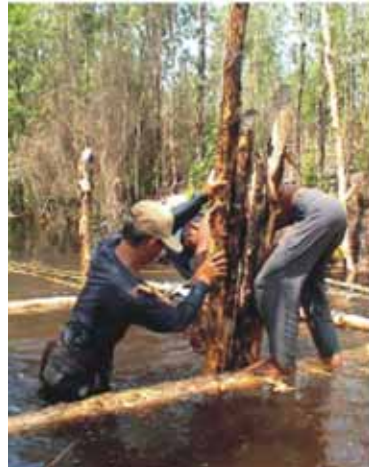
Illustration 80. *Inserting the Stakes*

- ❑ *Inserting the Stakes.* After all the cross supports had been put in, the next step was to insert the cajuput wood stakes, which were eight centimetres in diameter and three to five metres long. The stakes were planted vertically along the length of the cross supports, and then nailed at the top. At the bottom, which was submerged in the water, they were tied with plastic string.

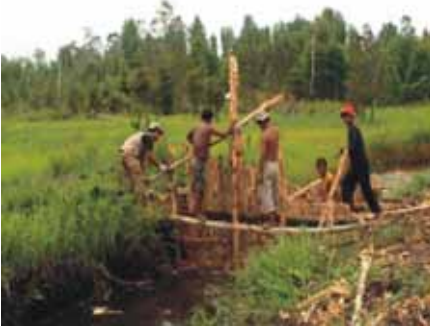
Illustration 81. *Installing Upright Supports*

- ❑ *Installing Upright Supports.* After the vertical stakes were inserted, the cross supports were strengthened with three to four vertical supports for each cross support. The vertical supports were approximately six metres in length with a diameter of 15-20 cm. They were embedded and clamped to the cross supports from two sides.

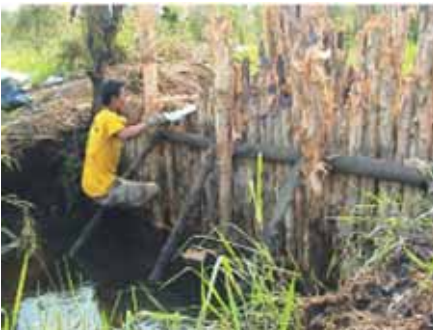
Illustration 82. *Inserting Supporting Posts*

- ❑ *Inserting Supporting Posts.* To strengthen the blocks four supporting posts were installed on the outside of the downstream side of the block. The posts were approximately six metres long with a diameter of 15-20 cm, and were installed at an angle of approximately 45°

- ❑ Poles should be used to support the outside downstream wall of the block in order to strengthen the block. This is especially important for blocks that are wider than five meters.
- ❑ The supporting poles installed on the right and left sides of the block should be deeply implanted in the peat on the canal's banks. This will strengthen the construction and protect against strong water currents in the canal.
- ❑ Wood planks which are used as vertical supports are not as strong as logs in withstanding the water current in the canal. For this reason, it is recommended that logs with the ends sharpened to allow for easier insertion into the mineral soil, be used. Belangeran wood is particularly suitable for the vertical poles due to its elasticity (it is not brittle) and the fact that it can withstand the peat water (it does not rot easily).

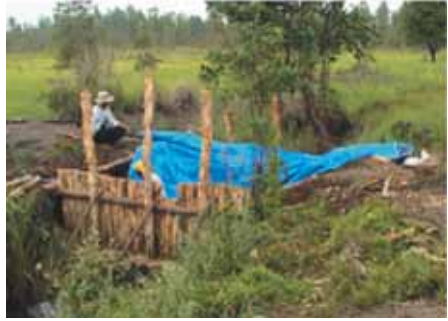
Illustration 83. *Installing plastic.*

- ❑ *Installing plastic.* A four by six metre tarpaulin was installed once the frame of the block was in place and evened up. Care was taken when attaching the plastic to make sure it did not rip, and that the frame of the dam was well planted at the bottom of the ditch. If the dam was not strong enough, there was a risk of the bottom of the ditch being eroded by the strength of the water current and that the plastic might then float up and be washed away.

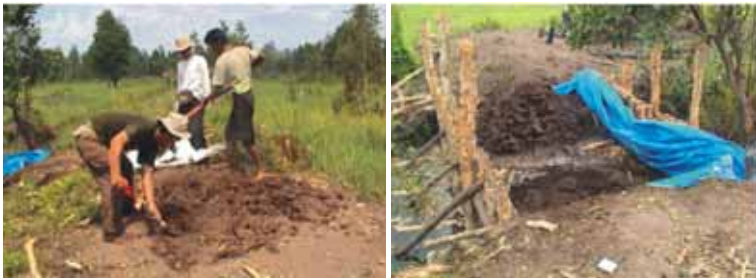
Illustration 84. *Filling with Soil*

- ❑ *Filling with Soil.* The earth to fill the dam (it is best to use mineral rather than peat soil) was taken from far downstream of the dam. The dam was filled in immediately after the plastic was attached. The earth was not taken from the vicinity of the block, because the cavities that would have been created from digging the earth would easily be eroded by water in the rainy season thus damaging the dam.

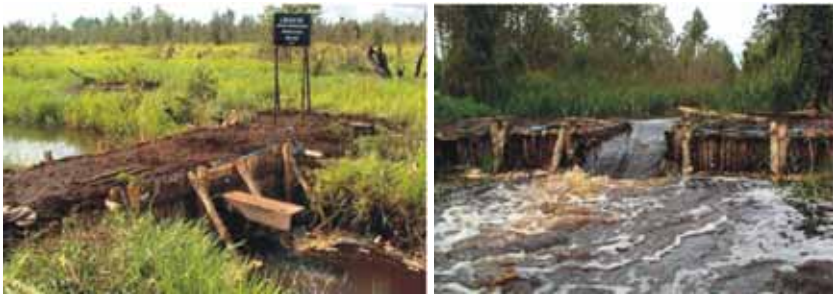
Illustration 85. *The spillway was built in the middle of the block*

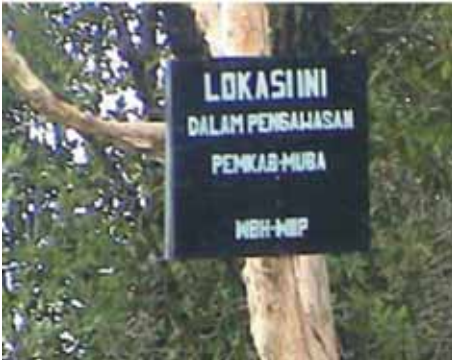
Illustration 86.
Information board

- *Information board.* After all the dams were completed, information signs were put up. These were installed in two locations, one near the dam and one at the mouth of the ditch (on the bank of the Merang River). This was considered important so that people who were carrying out activities in the area would not damage the dams.
